**DEPARTMENT OF TRANSPORTATION**

Contract #: 04-0120F4Cty: SF/ALA Rte: 80 PM: 13.2/13.9File #: 82.28**WELDING INSPECTION REPORT****Resident Engineer:**Siegenthaler, Peter**Address:** 333 Burma Road**City:** Oakland, CA 94607**Report No:** WIR-026065**Date Inspected:** 08-Aug-2011**Project Name:** SAS Superstructure**OSM Arrival Time:** 630**Prime Contractor:** American Bridge/Fluor Enterprises, a JV**OSM Departure Time:** 1500**Contractor:** Westmont Industries**Location:** Santa Fe Springs, CA**CWI Name:** Ruben Dominguez**CWI Present:** Yes No**Inspected CWI report:** Yes No N/A**Rod Oven in Use:** Yes No N/A**Electrode to specification:** Yes No N/A**Weld Procedures Followed:** Yes No N/A**Qualified Welders:** Yes No N/A**Verified Joint Fit-up:** Yes No N/A**Approved Drawings:** Yes No N/A**Approved WPS:** Yes No N/A**Delayed / Cancelled:** Yes No N/A**Bridge No:** 34-0006 L & R**Component:** Maintenance Travelers**Summary of Items Observed:**

**SAS-WB Traveler – Lower Truss Frame Assembly**

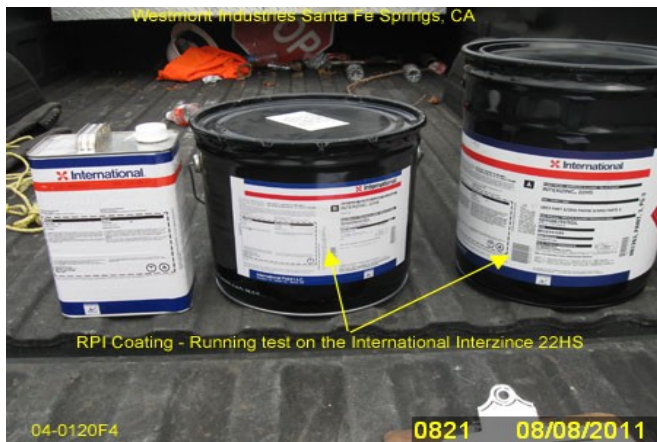
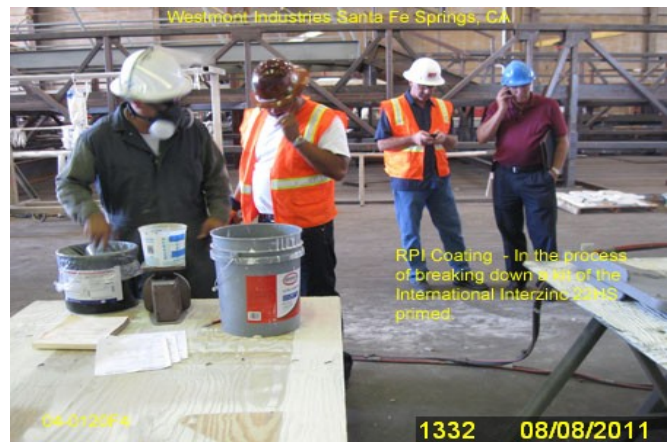
QA Inspector observed Mr. Nunez breaking down the Interzinc 22HS kit to start priming process. After mixing the Interzinc 22HS Mr. Nunez tried to spray the prime coating on the wall in the paint booth and decided that the prime was not flowing through the spray gun and ask the International Paint Representative about adding thinner. Mr. Dyer stated that RPI could at 10 percent. Mr. Nunez added 10 percent thinner to the prime coating mix. After mixing the thinner Mr. Nunez realized that RPI coating had not picked up the wrong thinner for the prime coating application. The thinner RPI purchased was for the International Interfine 979 Acrylic Polysiloxane top coat application. Mr. Nunez when informed QA Inspector that RPI would have to order the thinner for the International Interzinc 22HS Inorganic Zinc-Rich Silicate and that RPI will set up the test again when the thinner arrives. QA Inspector informed SMR Mr. Nicolai Hvass of the above information.
